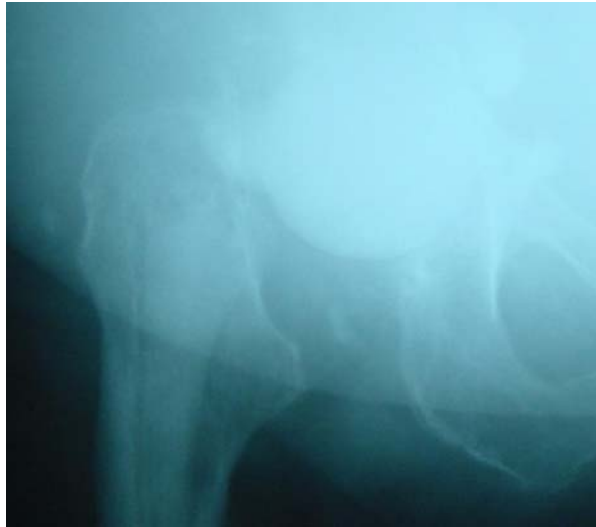
Figure 2. AP view of the left hip showing a fracture of the cement spacer at the level of the neck of the cement spacer mould (case II).

Full weight bearing or excessive movement, as seen in the above two cases, puts the fragile cement insert under tremendous strain and this may lead to fatigue failure.

The moulded cement spacers should, therefore, be treated as just ordinary spacers aimed to maintain the soft tissue planes and length. Full weight bearing mobilisation should be avoided. Commercial designs of the cement spacers may be improved by the addition of a hard shell composed of an inert (non reactive) material with high tensile strength that can withstand weight-bearing forces.

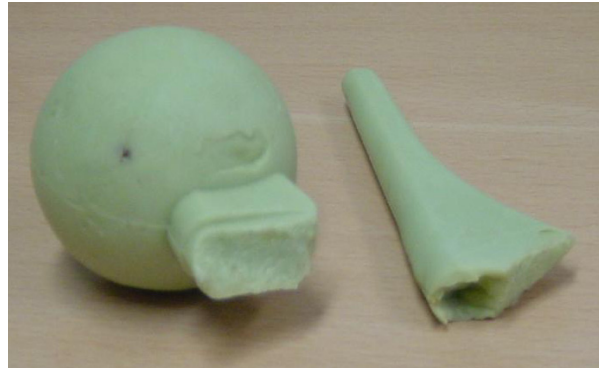
Figure 3. The fractured cement spacer mould as removed from the hip.
