FRACTURED CEMENT SPACERS—A REPORT OF TWO CASES

Rajesh Botchu, R. Anwar, KJ Ravikumar

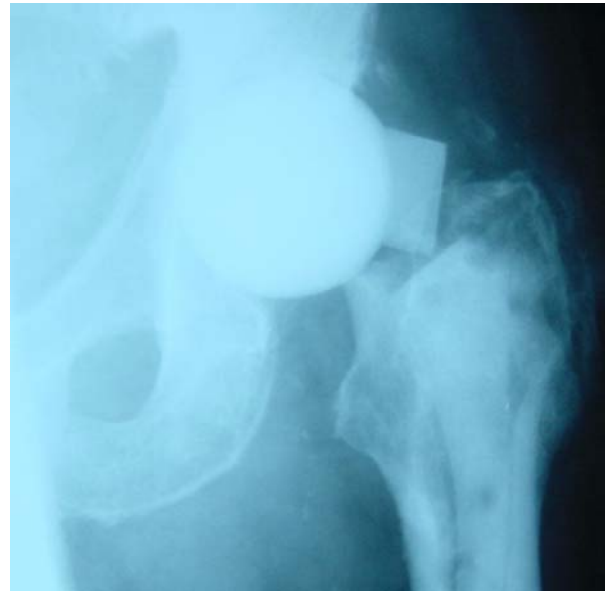
On examination, the left leg appeared shortened and externally rotated. The movements were significantly painful. The distal neurovascular status was entirely satisfactory. The scar over the lateral aspect of the hip had healed well with no local signs of infection and the inflammatory markers were within normal limits. A radiological examination revealed a fracture of the cement spacer at the level of the spacer neck (Figure 1).

Subsequently, a second stage revision was performed. A fracture was found at the level of the junction of the neck and the stem of the spacer. The integrity of the rest of the spacer mould appeared well preserved.

Figure 1. AP view of the left hip showing a fracture of the cement spacer at the level of the neck of the cement spacer mould (Case 1).

Full weight bearing or excessive movement, as seen in the above two cases, puts the fragile cement insert under tremendous strain and this may lead to fatigue failure.

The moulded cement spacers should, therefore, be treated as just ordinary spacers aimed to maintain the soft tissue planes and length. Full weight bearing mobilisation should be avoided. Commercial designs of the cement spacers may be improved by the addition of a hard shell composed of an inert (non reactive) material with high tensile strength that can withstand weight-bearing forces.

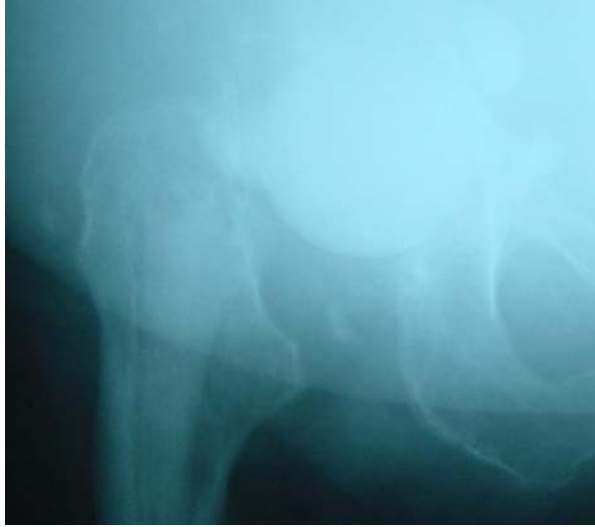
On examination, the leg appeared externally rotated and shortened. The movements of the hip produced severe pain. Examination of the distal leg including the neurovascular status did not reveal any abnormality. The patient remained afebrile throughout, and the inflammatory markers showed a downward trend. A radiological examination of the hip suggested a fracture of the cement spacer mould (Figure 2).

Figure 2. AP view of the left hip showing a fracture of the cement spacer at the level of the neck of the cement spacer mould (case II).

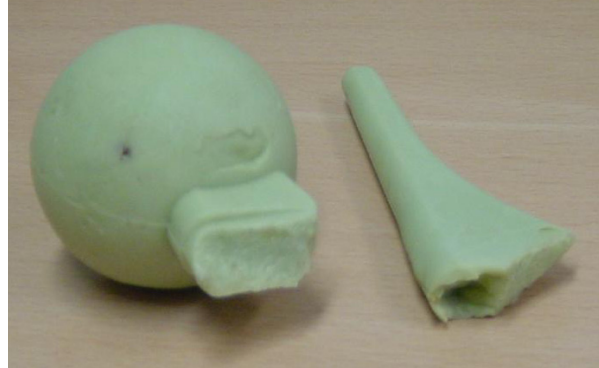
The patient, therefore, underwent a second stage revision after removal of the spacer and showed an uneventful recovery. The level of the break in the spacer and its overall appearance were very similar to that in case I (Figure 3).

Figure 3. The fractured cement spacer mould as removed from the hip.
